VOLUME 1 ISSUES8&9 FIRST AND SECOND QUARTER 2002 DOUBLE ISSUE

# ROLLS-ROYCE SILVER CLOUD. II. III. AND PHANTOM V BENTLEY S, S2 AND S3

# POST"55"

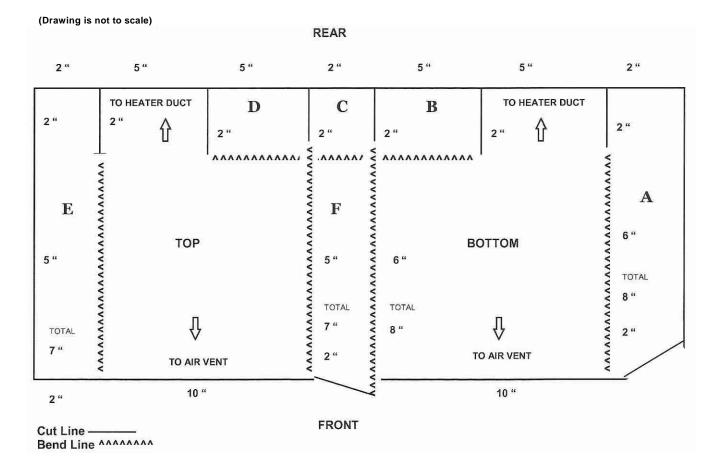
#### **LEFT SIDE AIR SCOOP**

- 1. Move flap D over next to flap E.
- 2. Move flap B over next to flap A.
- 3. Add a bend line to the 2" top of flaps E and A.
- 4. Leave flap C in place. Don't bend it.

- 1. Secure a sheet of aluminum thin enough to bend easily. At least 26" by 8"
- 2. Replicate the attached drawing on the aluminum. I found that a Sharpie Ultra Fine Point Permanent Marker Pen writes well on metal.
- 3. Using your tin snip. Cut out the pattern.

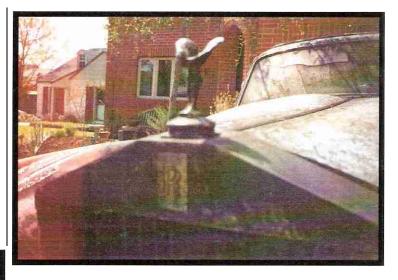
Smokey arrives at her new home ready to begin her refurbishing process and start a new life.

Close up photographs of Smokey show the damage she received from the fire surrounding her .

Though the car itself never caught fire, it suffered from the affects of extreme heat and a deluge of water. The once stunning shell gray and midnight blue body was reduced to a murky brown and red body sitting on four cracked and melted tires. In fact, some of the leading had liquefied and appeared to be dripping down the front fender. The windshield was blackened, cracked and warped. The driver's window was completely shattered from heat. Likewise, all lenses had melted and were dripping down the body. While the interior of the car was unharmed by heat, it was severely damaged by an excessive amount of water.
